CIVIL AERONAUTICS BOARD

ACCIDENT INVESTIGATION REPORT

COMPANIA CUBANA DE AVIACION, S. A. AND U. S. NAVY,
KEY WEST, FLORIDA, APRIL 25, 1951

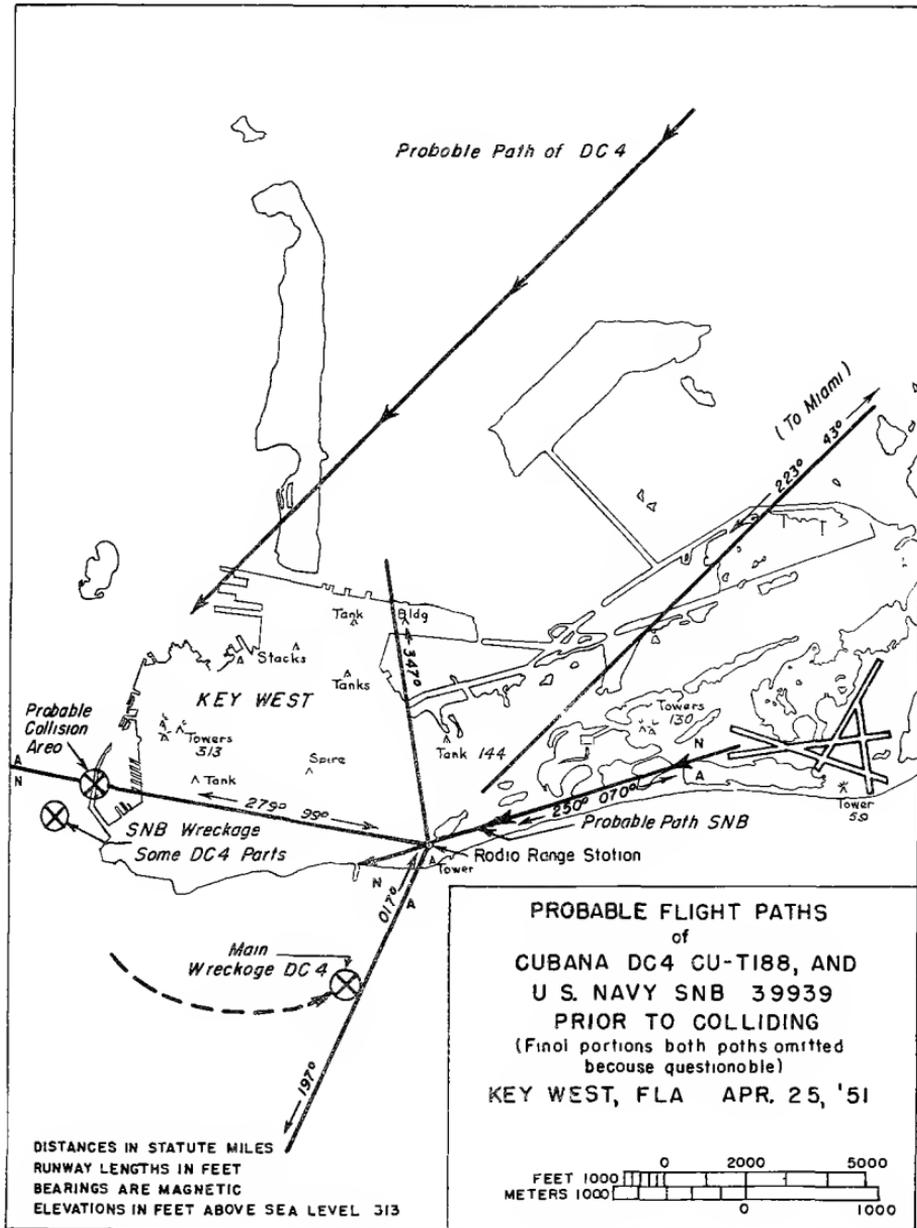
Appendix I

On the morning of the same day a twin-engine Leechcraft, Navy designation SNB No 39939, was scheduled for a simulated instrument training flight from the U. S. Naval Air Station,⁵ Key West, Florida, at 1120. The flight, to be conducted under visual flight rules, had no altitude or area assignment other than that necessary to accomplish the training mission. One portion of the mission requires a flight inbound on the east leg of the Key West Radio Range on a heading of 250° M, at an air speed of 140 knots. Upon recognition of the cone, the pilot proceeds outbound on the west leg of the range on a heading of 279°, reduces speed to 105 knots, lowers the landing gear and descends to an altitude of 1,300 feet. A procedure turn is then made and the prescribed pattern followed for a simulated instrument approach to Boca Chica Airport (See Appendix I).

Shortly before the accident, a Navy SNB was observed at an estimated altitude of 4,000 feet approaching along the east leg of the Key West Radio Range, which heading toward the Station is 250° M. Since this training flight involved simulated instrument approaches on the Key West Radio Range, it is assumed that such an approach was being made at the time of the collision. This assumption is further supported by the fact

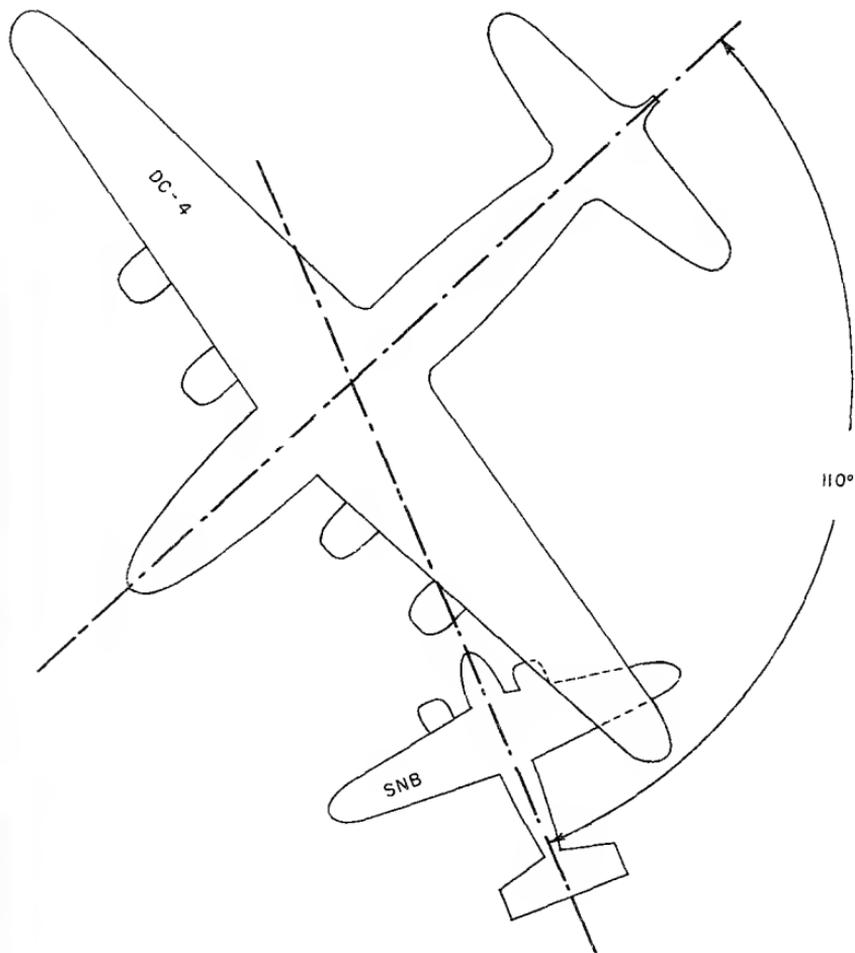
Appendix II

Among the recovered portions of both aircraft, sufficient evidence was found to establish the position of the aircraft relative to each other at the moment of initial impact. The right propeller of the SNB had deep gouges on the leading edge of both blades. The section of the DC-4 left wing recovered with the SNB wreckage showed evidence of having been cut by a revolving object at wing stations 588 1/2 and 540 1/2, the cutting action being from the front to the rear of the wing and parallel to the longitudinal axis of the DC-4. The cut on the DC-4 left wing at station 588 1/2, which was made by one blade of the right propeller of the SNB, was the first contact between the two aircraft. The cut in the DC-4 left wing at station 540 1/2 by the second blade of the SNB right propeller, and the contact of the tip and leading edge of the DC-4 left wing with the

right side of the SNB fuselage, followed almost simultaneously. There was evidence of subsequent impact between the two aircraft, however, the damage was of such a nature that it was not possible to determine any sequence of events. The SNB propeller cuts in the DC-4 left wing indicated that the angle between the longitudinal axis of the two aircraft at the moment of impact was approximately 110° . (See Appendix II)

ANGLE OF COLLISION AS DETERMINED BY EXAMINATION OF WRECKAGE
CUBANA DC-4 CU-T188 AND U S NAVY SNB 39939
KEY WEST, FLA APR 25, '51
